**Subject:** Freezer drawer gasket not sealing completely at the top left corner.

| SERVICE BULLETIN | |
| Product: | French Door Refrigerators |
| Bulletin Number | ASC20140910001 |

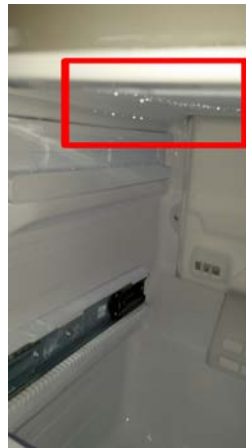
**Symptom:** Condensation and frost forms at the top of the freezer due to a gap between the freezer door gasket and the cabinet.

**Condensation**

- Open the freezer drawer and remove the upper tray.
- Inspect the rear corners for a bowed section in the liner.
- If the bowed section is present, replace the upper tray with the new part, DA97-08439D, which includes rails that allow for proper clearance at the bowed area. The left and right rails have been redesigned.

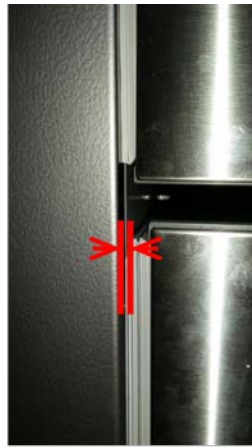
**Gap**

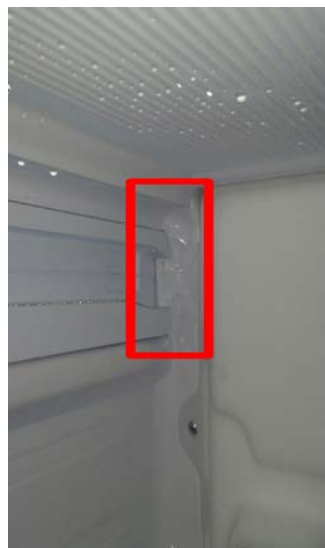
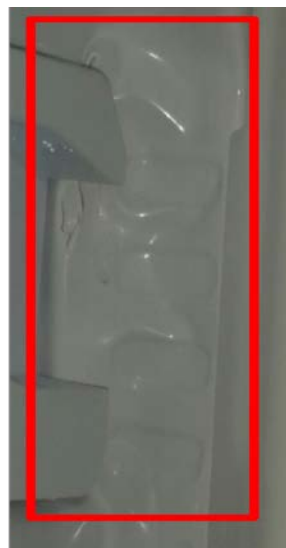
**Root Cause:** The rear wall of the freezer compartment is bowed out approximately 8.8mm. The upper freezer tray rail hits the bowed area, preventing the drawer from closing properly.

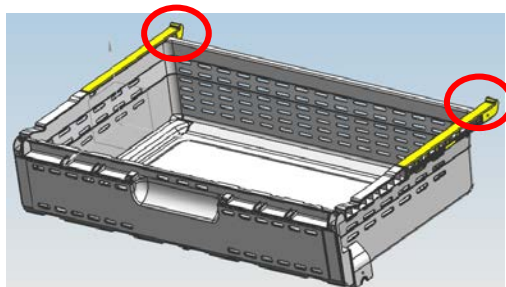
#### **New assembly with new style rails**

**Part Code: DA97-08439D**
