| Title | <b>Unit Does Not Spin / Cycle Stops</b> | | |
| Create Date | October 30, 2017 | Service Bulletin Number | <b>ASC20171030001</b> |
| Revision Date | 3/27/2018 | Models | WA40J3000AW/AA<br>WA40J3000AW/A2 |

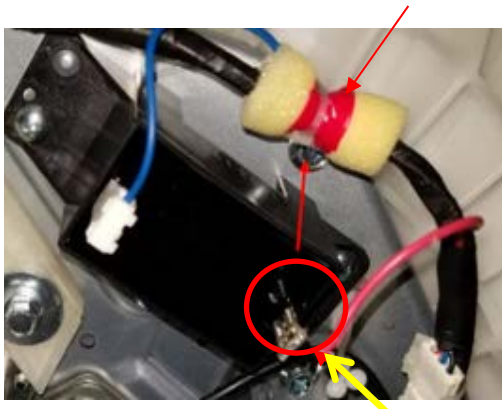
Wire harness tie can become disconnected from the motor die causing the red or blue wire to disconnect from the motor capacitor connector.

Red Wire disconnection

- Determine if the red or blue wire from the main wire harness is disconnected from the motor capacitor connector.
- **IMPORTANT: If the red or blue wire is disconnected, the WIRE HARNESS (DC93-00702A) MUST BE REPLACED.**
- **✖ Reconnecting the wire harness only may cause the same problem later.**

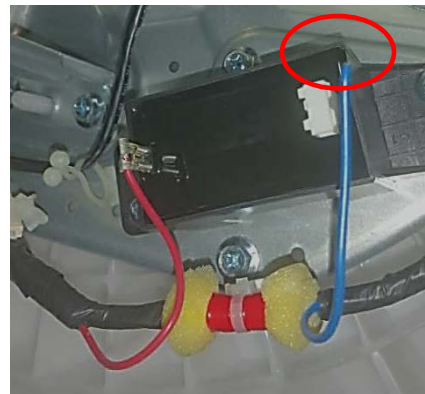
Blue Wire disconnection
