**SUBJECT:** Frost build-up on the underside of Ice maker, noise from ice room

| SERVICE BULLETIN | |
| Product: | French Door Refrigerators |
| Bulletin Number | ASC20151125001 |

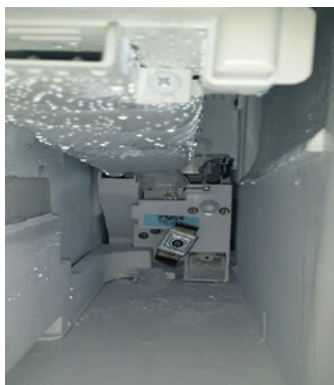
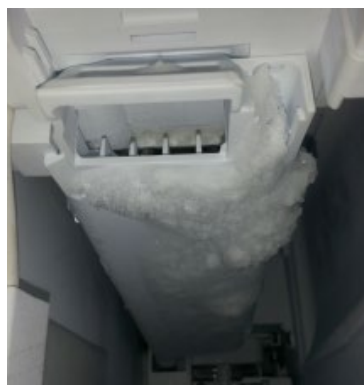
Ice crystals and water droplets form at the bottom of the ice maker.

If this occurs, the fan will stop running. Without air movement, excessive heat will not be removed, causing condensation that forms under the ice maker, as shown in the pictures above.

- 1. Remove the ice maker and the auger motor/fan assembly.
- 2. While parts are removed, make sure the ice room is completely free of residual ice or frost.
- 3. Check for a gap on the left ice room floor.

- 4. If a gap exists, use Epoxy to seal the gap. Part number: DA81-05595A A/S Epoxy
- 5. Replace the auger motor/fan assembly with a new one.

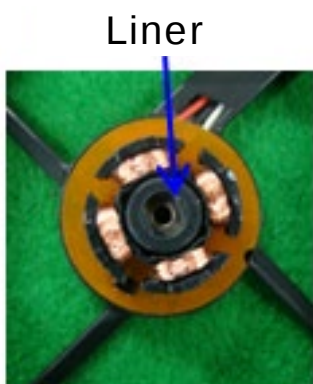
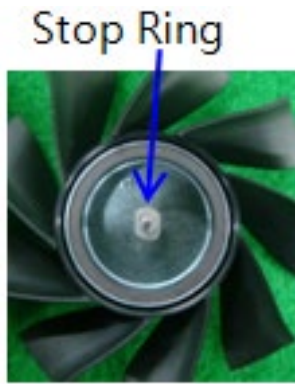
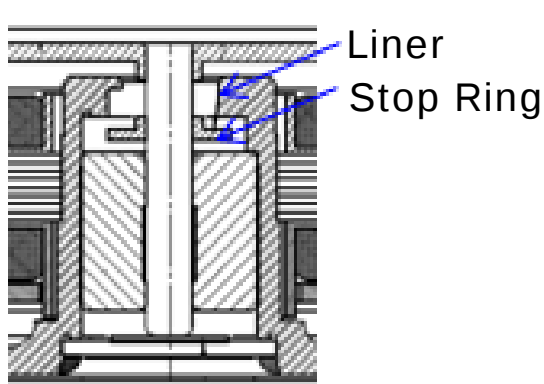
**Original Fan:**

The ice room fan has a “c” shaped hole and “c” shaped shaft stopper, which can fall out of correct position when the fan motor stops. Fan motor turns can become slow and noisy or just stop completely.
