| Service Bulletin | |
| Product | FD Refrigerator |
| Bulletin Number: | ASC20150701001 |

**SUBJECT:** No cooling in the Fresh Food (FF) section of RF32FMQDBSR refrigerators produced PRIOR to June, 2014

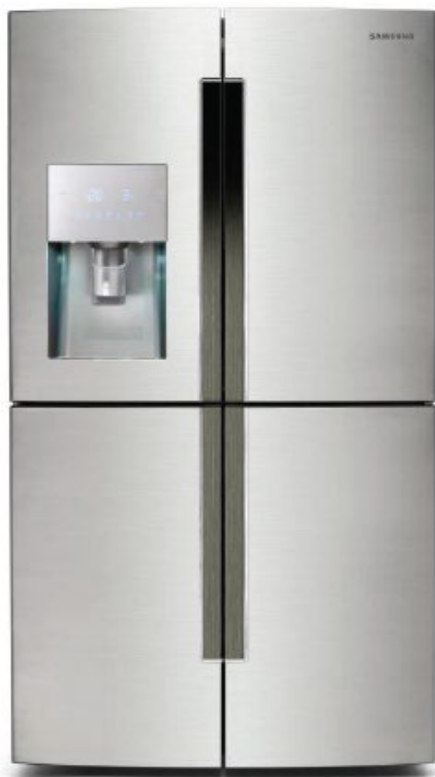
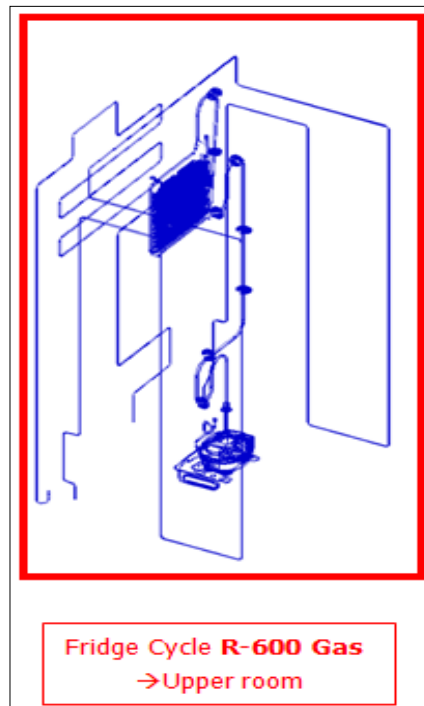
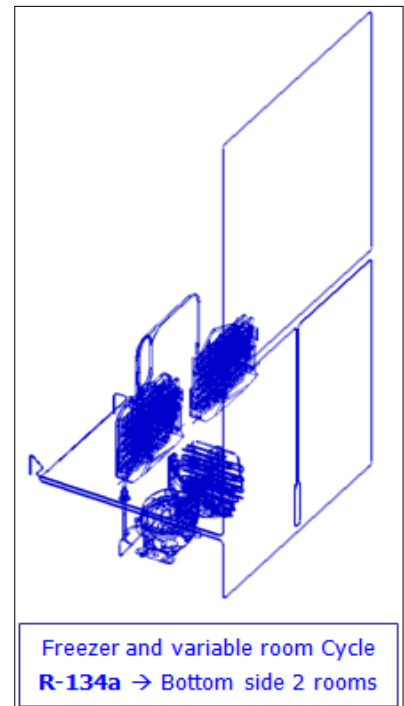
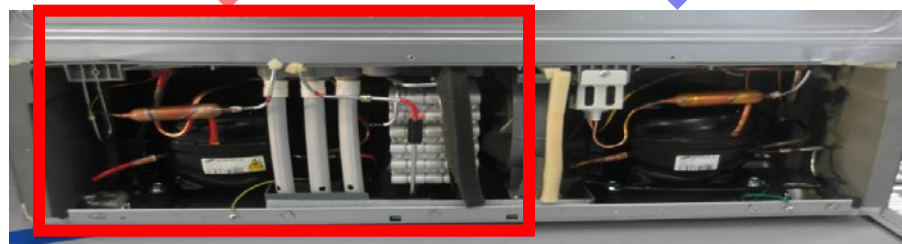
- This refrigerator contains 2 complete sealed systems with 2 compressors, one for the freezer and variable room and a separate one for the fresh food section.
- The Fresh Food sealed system and compressor use the refrigerant R600a.
- If the problem is with the sealed system in the FF section, the unit is non-repairable.

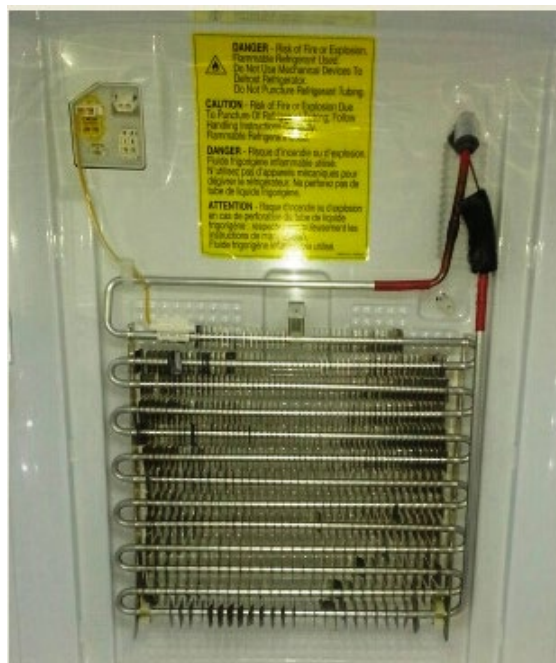
1. Look at the displayed temperature. It should be the actual temperature, not the set temperature. For no cool, the displayed temp will probably be in the mid-50s and blinking.
2. Check if the FF compressor is running.
  - a. If the compressor is running, remove the evaporator cover and check for any frost on the evaporator. No frost or an incomplete frost pattern indicates a leak. See the picture below.
  - b. If the compressor is not running, check for failure codes and/or an inverter failure. (The inverter lights will be blinking or there will be an open fuse). Inverters can be replaced.

If the R600a system (identified by red paint on the tubing) is leaking or the compressor has failed, **do not attempt to repair**. Contact Samsung Tech Support from the home for further instruction.
