| SERVICE BULLETIN | |
| Product: | Bottom Mount and French Door Refrigerators |
| Bulletin Number | ASC20151029001 |

**Subject:** Water leaking under crispers. For these models only, this bulletin supersedes any previous bulletin.

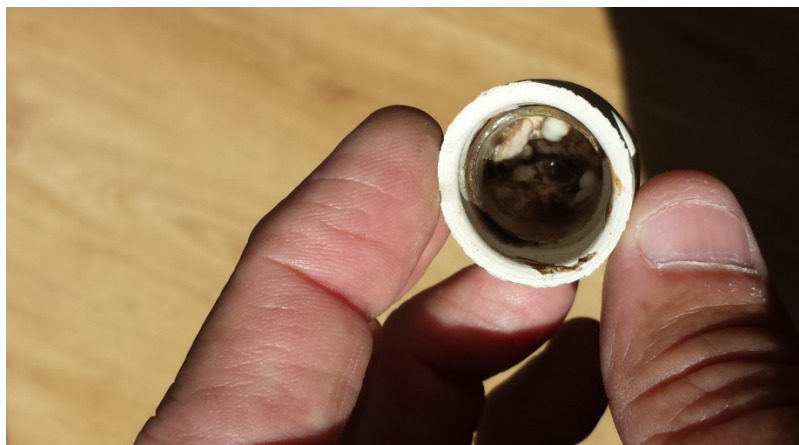
**Symptom:** FF section drain tube becomes clogged due to debris in the “duck bill”. The defrost water then backs up into the drain pan under the evaporator, where it will freeze. Every time the evaporator defrosts, water will then run over the drain pan, collecting under or in the vegetable drawers.

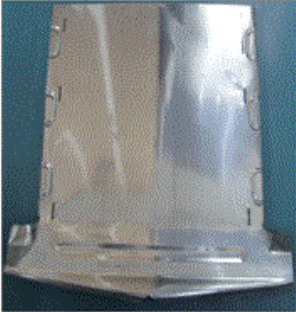
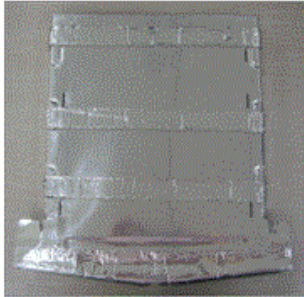
| Before Sep. 30, 2013 | Since Sep. 30, 2013 | Since 23. Apr. 2014 |

**Evaporator Drain Pan**

Revisions (back and bottom of the evaporator drain pan assembly, foam seals installed)

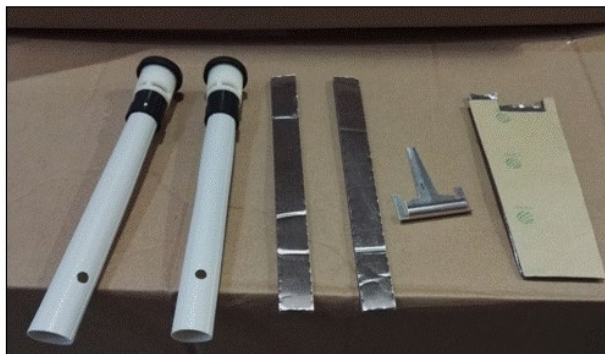
**Service Kit: Part Code DA82-01415A Leakage Kit**

### Kit Contents:

- 2 new drain tubes with caps
- 1 foam seal for the bottom of the drain plate
- 2 foam strips for the back of the evaporator drain plate
- 1 defrost heater clip (only for models produced prior to 2011).

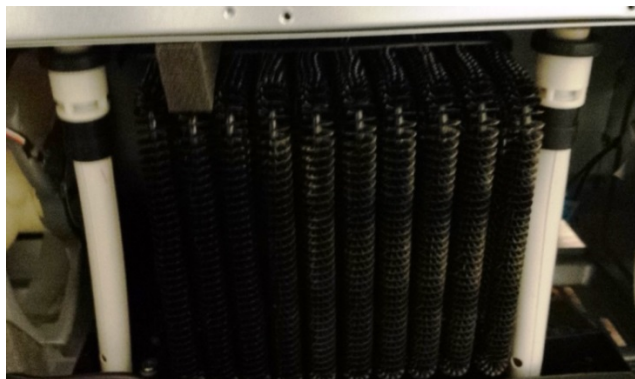
**Note:** The most important component of this repair is the installation of the new drain tubes after you have cleared the drain. As long as these tubes are installed, if the new duck bill becomes clogged, the drain water cannot travel back up the drain pipe and freeze again. This will also prevent freezing in the freezer drain.

7. **Install the two new drain tubes with caps.**
