| Title | French Door Direct Cool Ice Maker Frozen | | |
| Create Date | 2017.05.24 | Service Bulletin Number | ASC20170602002 |
| Symptom | No ice | Frozen Ice Room | Ice Bucket Stuck with Frost |

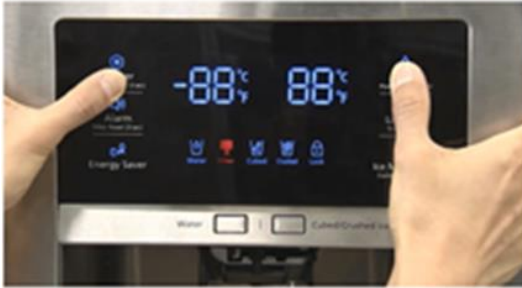
Place unit in Self Diagnostic Mode and check for Fault Codes

| Code | Item |
| 14 C | Ice Maker(FF) Sensor Error |
| 15 C | Ice Room Sensor Error |
| 39 C | Ice Maker(FF) Function Error |
| 40 C | Ice Room - FAN Error |
| 61 C | Ice dDuct heater Error |

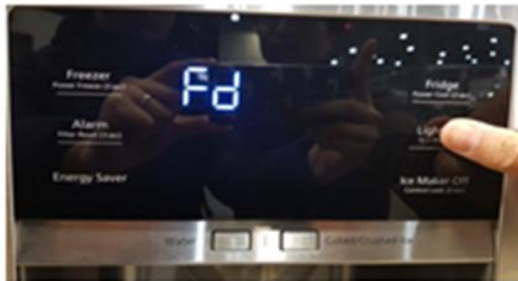
2. Place unit in Forced Defrost Mode (Fd) for at least 5 minutes to melt ice from around cooling loop

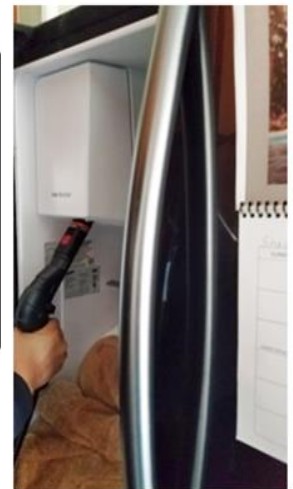
**NOTE:** If the ice bucket is stuck, use a steamer to melt the ice until you can remove the bucket. Be sure to place a towel under the ice bucket to catch water as it drips down as shown.

**NEVER** use a heat gun or hair dryer to defrost the ice room.

**Using a heat gun or hair dryer to defrost the ice room may cause the plastic liner to melt creating permanent damage**

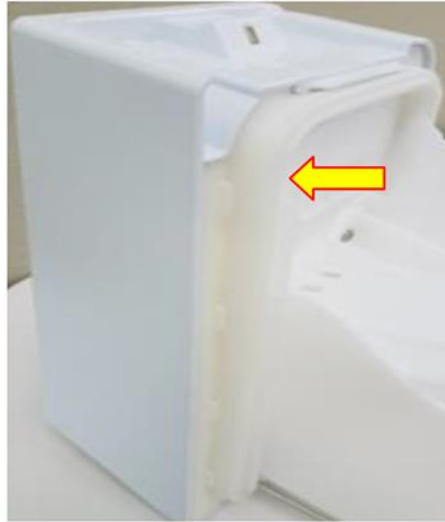
- ① Pull out the Ice Bucket from the Ice Room. (If the bucket is stuck, use a steamer to melt the ice.)
- ② Check Ice Bucket for cracks or fractures
- ③ Check the gasket around the edge making sure it has not ripped, cracked, or become too rigid, preventing a proper seal

**If damage is noted,  
replace the ice bucket**

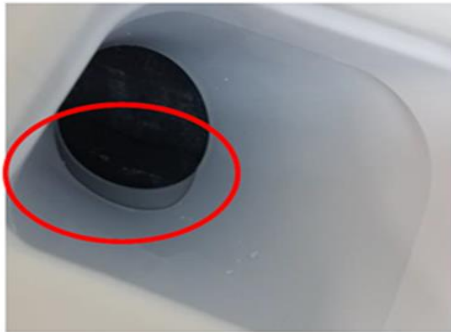
Add Some water to the Ice Route  
for leakage testing

No leak

Leak

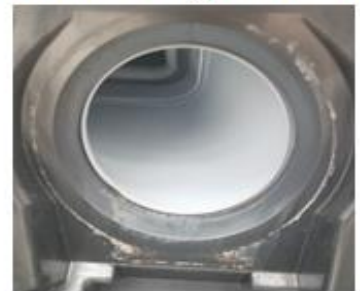
Inspect the Ice Route flapper. Ensure the rubber is still soft and pliable, has no tears or rips, and that the flapper is in the fully closed position when out. Also inspect the ice dispenser opening for cleanliness. If build up has occurred, wipe clean before reinstalling the Ice Route.

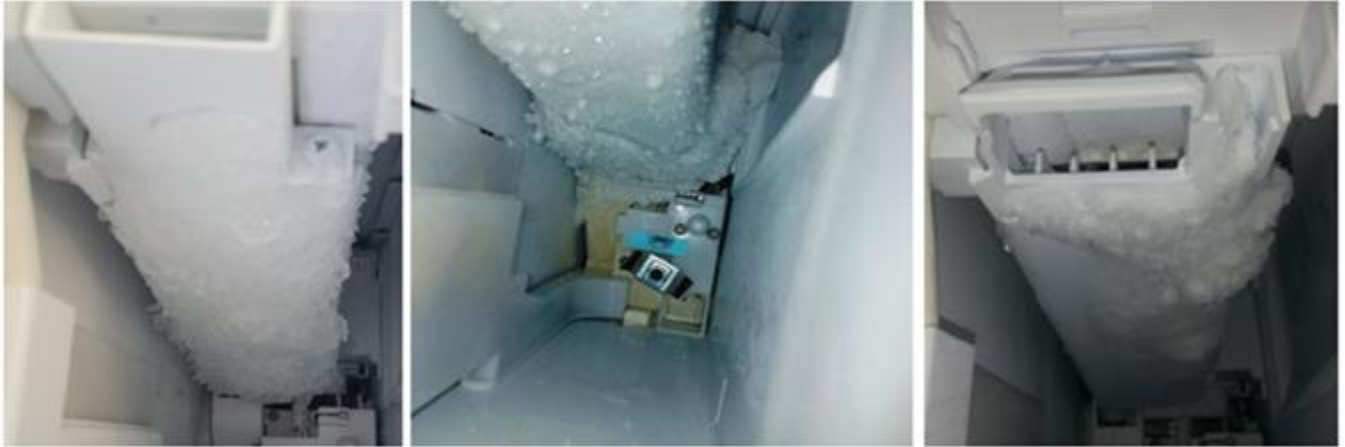
You **MUST** remove **ALL** ice from the ice room and auger area using a **STEAMER**

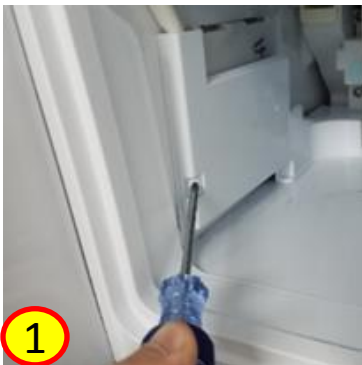
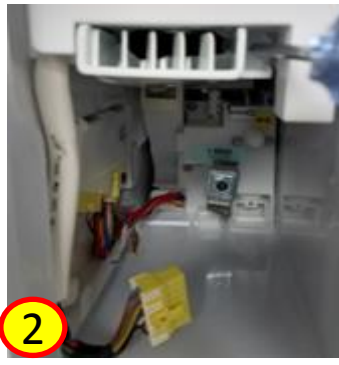
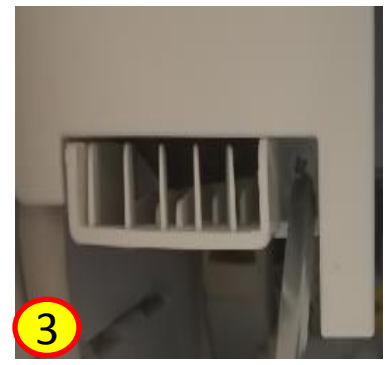
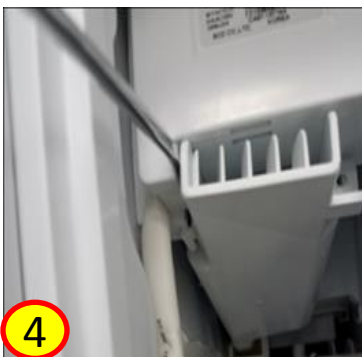
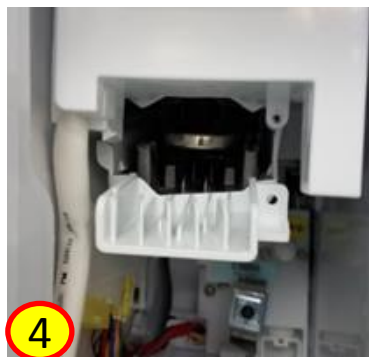
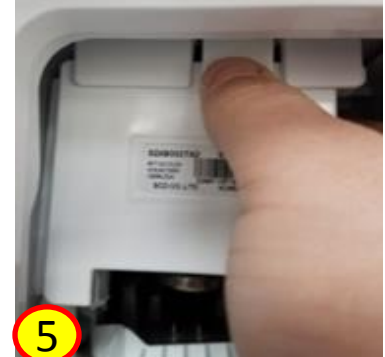
- 4 Disassemble the ice maker

1. Remove the left screw, and then open the Harness Cover.
2. Disconnect the Ice Maker cable.
3. Unlock the Drain Duct by removing the upper right screw.
4. Unlock the left hook, and then \*open the Drain Duct.
5. Unlock the upper hook, and then pull out the Ice maker from the opening of the Drain Duct.

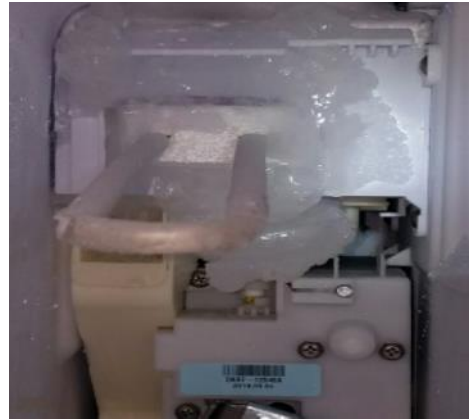
## ⑤ Check for Frost Symptoms in the Ice Room

1. Check for traces of water spray in the upper ice room area.
2. Check for frost in the air flow path (L-Duct).
3. Check for frost in the drain pipe of the Auger motor.
4. Check for ice or frost on the ice room bottom.

**Continue steaming the unit to remove all traces of ice to allow for the safe removal of the auger motor assembly.**

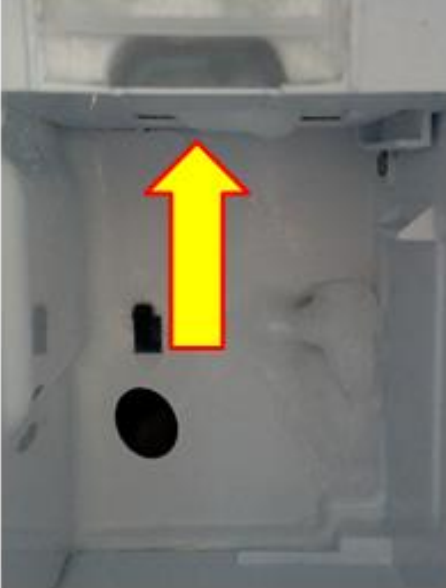
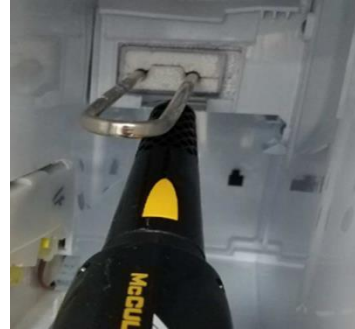
Inspect the air channel above the Auger assembly and remove all traces of ice from this area. Failure to do so will create new ice build up there and on the floor, side walls, and rear.

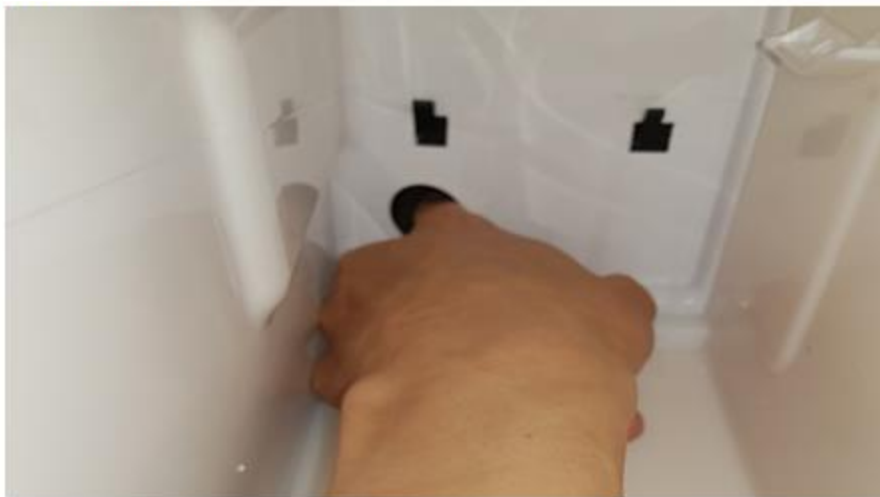
- ⑧ With the Auger Motor Assembly removed, inspect the drain for the ice room. Place your finger into the drain area to feel for any foam remnants or ice blockage etc. Remove any and all material found.

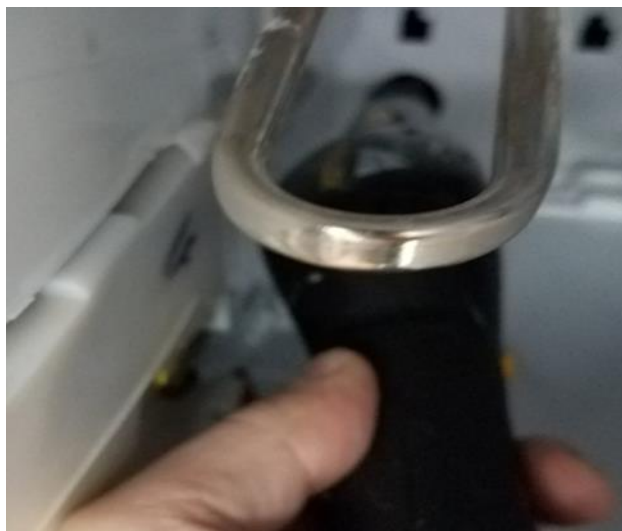
If Ice is found, use a steamer to remove and ensure you have flow from ice room to drip pan in the rear. Drains must remain open.

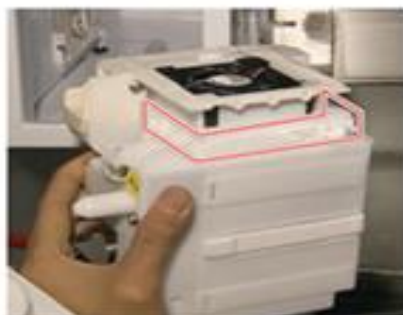
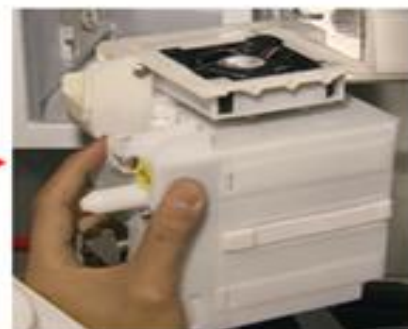
- ⑨ Check if there is Styrofoam packing still in the auger motor, and remove it.

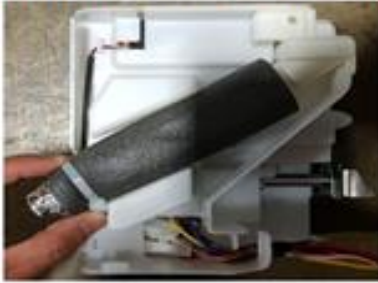
- 10 Inspect the zip tie on the drain. Make adjustments as needed so the insulation and zip tie does not prevent proper installation of the auger assembly.

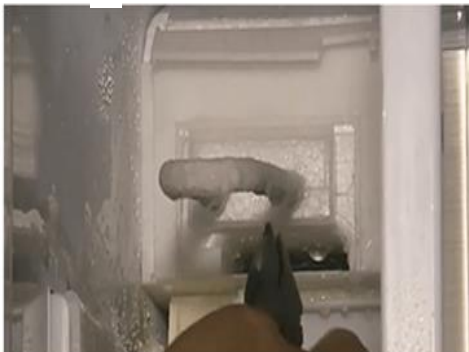
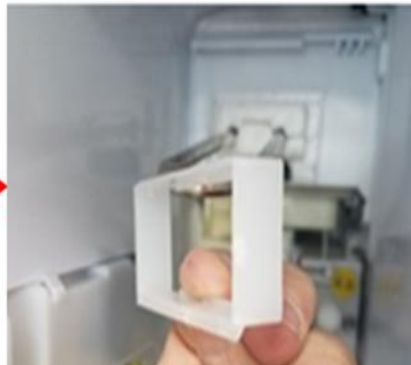
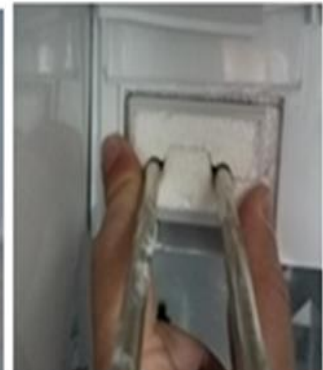
- 11 Take out the bracket surrounding the cooling loop and discard it. Install the new bracket included in kit, Part # DA82-02367A

**IMPORTANT:** This step must be completed, even though in many cases the parts look identical.

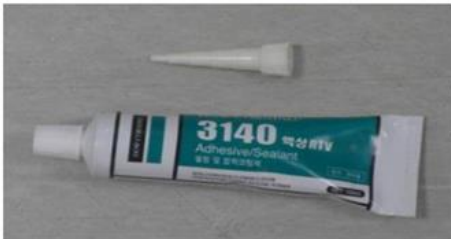
- 13 Sealing the ice room with RTV sealant. Seal gaps that may exist in the ice room sides and floor.

**NOTE:** Only use Samsung provided RTV sealant. No substitutions or other products are authorized for use in this repair step.

Part number required:  
**DA81-05595A**

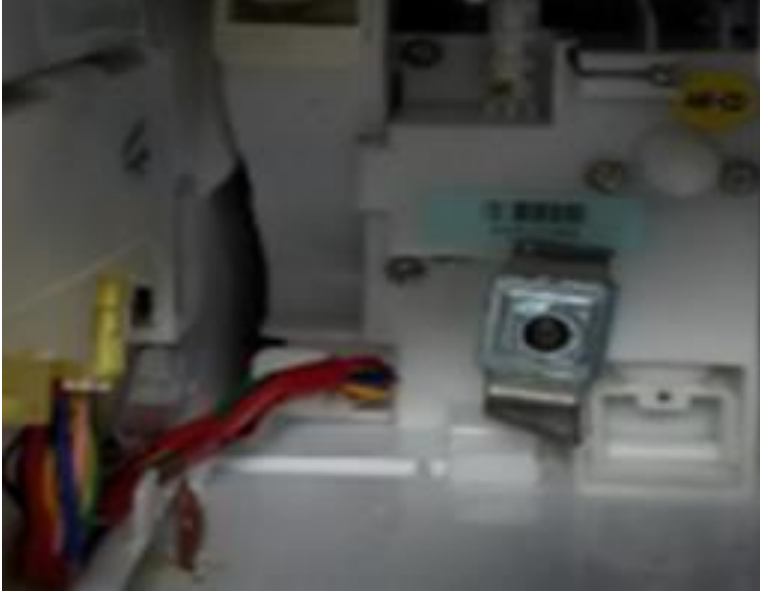
- 14 Re-install the auger motor assembly ensuring it is installed fully to the rear and locked into place with the lock tab. Reconnect auger motor wire harness to the connection point on the left wall making sure to route the wiring properly.

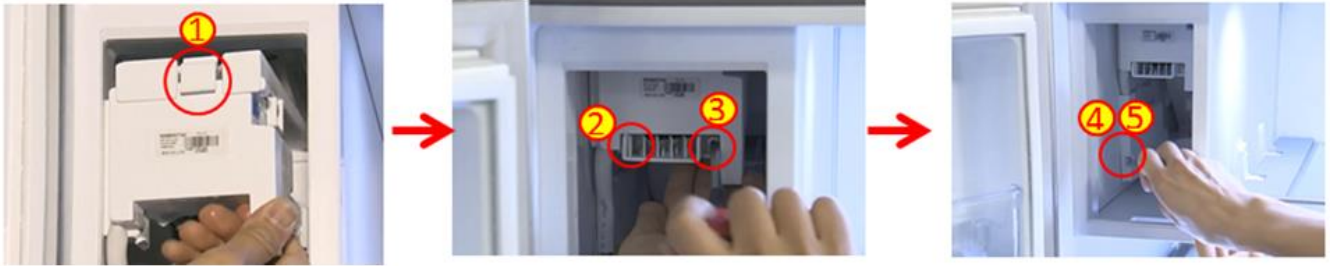
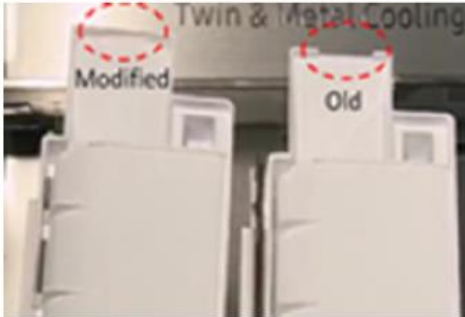
- 16 Reassemble the ice maker

1. Insert the ice maker into the opening of the Drain Duct. Lock the upper hook with 'click' sound.
2. Lock the left hook with 'click' sound to close the Drain Duct.
3. Insert and tighten the upper right screw to lock the Drain Duct.
4. Connect the ice maker cable.
5. Close the Harness Cover, and then screw in and tighten the left screw.

**Order and replace the Ice Maker Assembly for all service cases.**

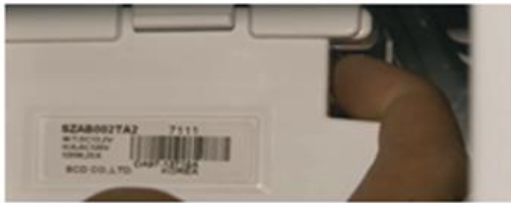
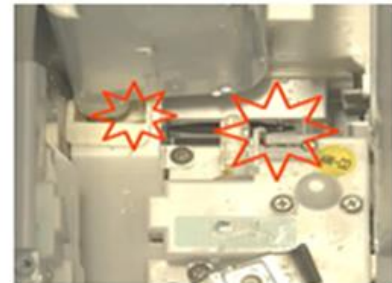
② Press "Test Mode" button and check for leaking water or functional failure

When pressing test, listen for the chime. This indicates the test function has begun. This process takes 6 minutes to complete and will produce a shortened fill at the very end of the process. Check for any leaking, spraying, or drips after the 6 minute test is completed.

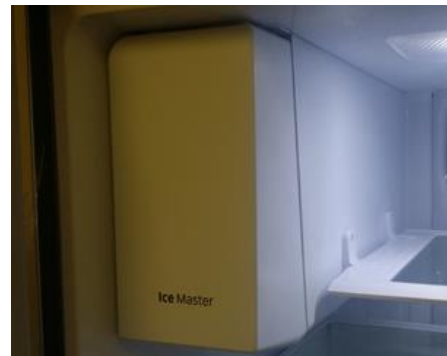
③ Re-install the Ice Bucket.

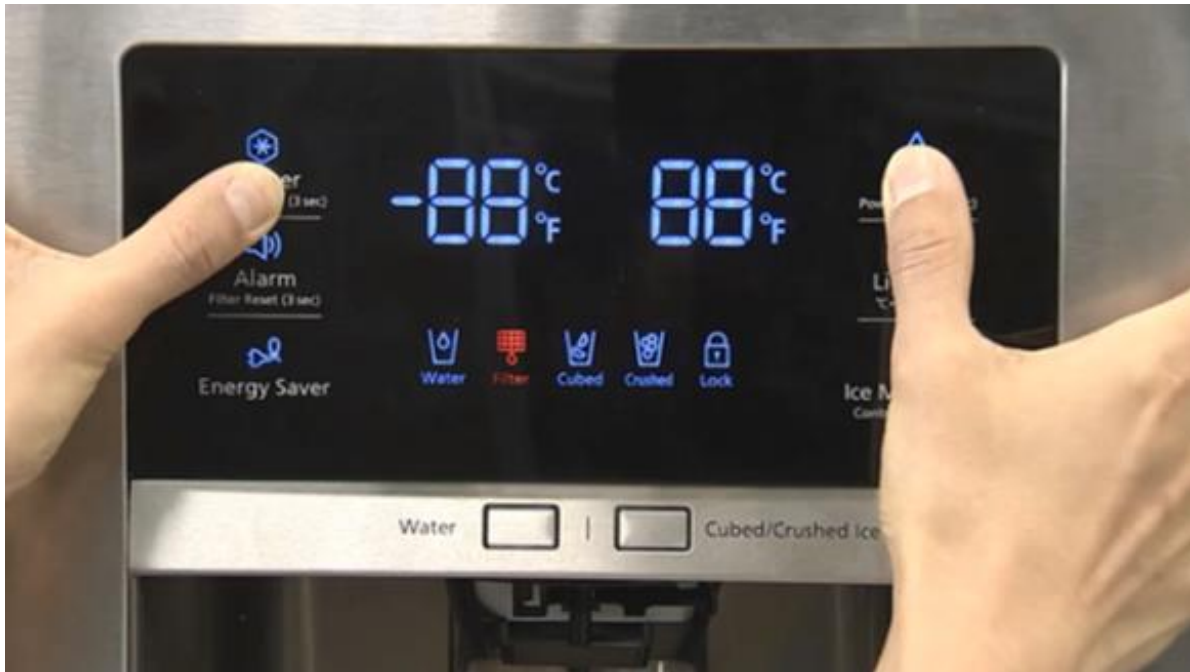
- ②0 Finally, to complete the repair, place the unit into Self Diagnosis mode to ensure the unit has no other error codes and is operating as it should.
