| Title | Cavity Floor Cracking on Gas Oven Range Models | | |
| Create Date | March 10 <sup>th</sup> , 2017 | Service Bulletin Number | ASC20170310001 |
| Revision Date | | Models | All Gas Range Models |

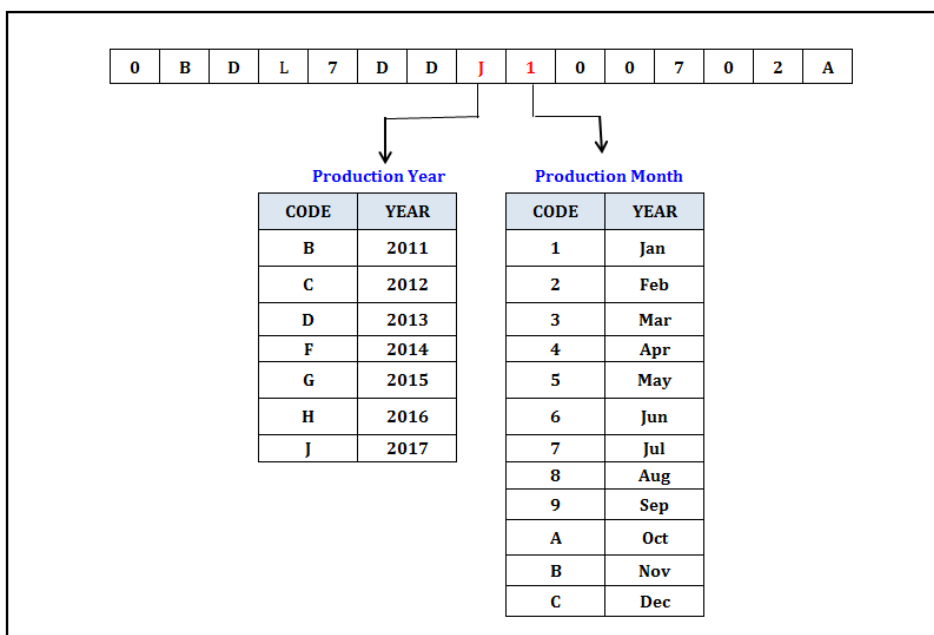
## How to determine the production date from the serial number:

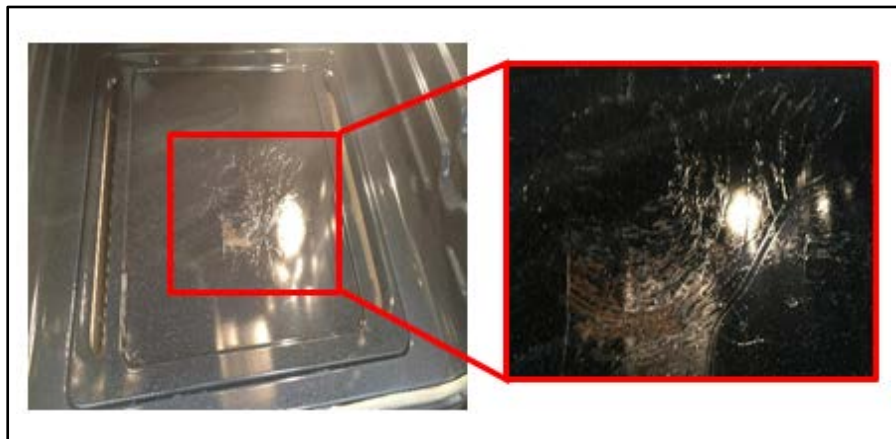
If the bake spreader comes in direct contact with the floor panel, over time, the oven floor coating may start to crack and peel.

The bake spreader has been modified to prevent contact with the floor panel. To resolve the issue, replace the bake spreader and the floor panel.
