**SUBJECT:** Ice room or ice maker frozen or leaking, fan noise from ice room

| SERVICE BULLETIN | |
| Product: | French Door Refrigerators |
| Bulletin Number | ASC20150717001 |

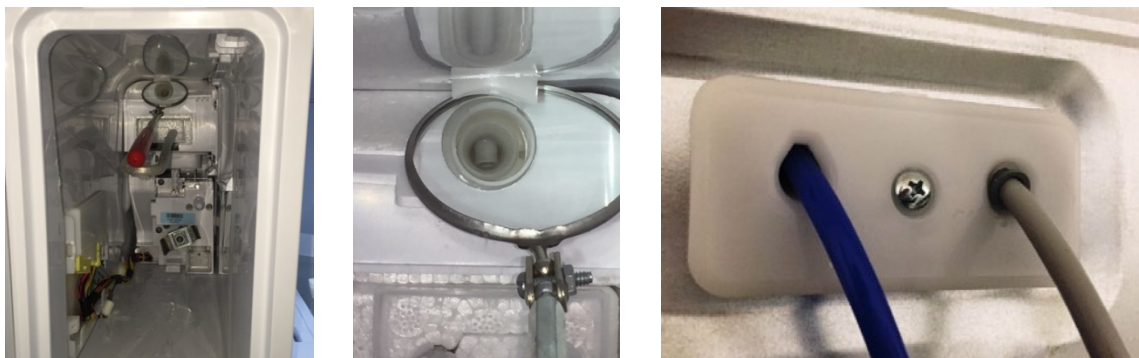
The water hose to the ice room fill tube is inserted too far into the fitting which causes water to splash out during the ice maker fill cycle. This water settles in the ice maker tray, causing condensation and frost.

- Remove the ice maker, and then check the fill opening using an inspection mirror (see pictures below).
- The fill tube may be inserted too far.
- If tube is inserted too far, the fill tube (grey) can be pulled back slightly.

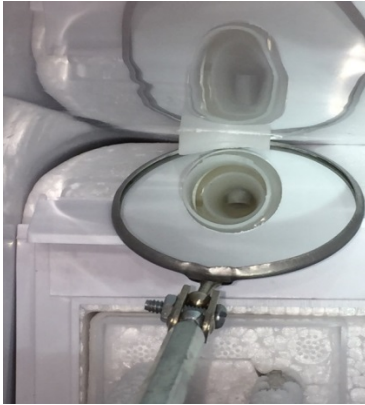
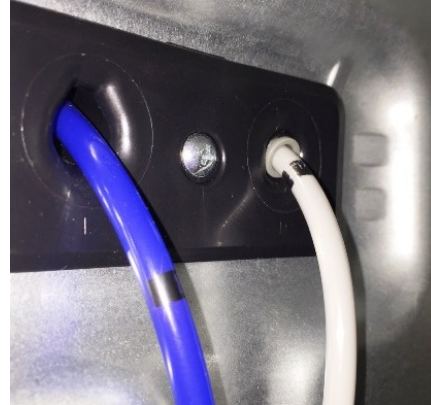
Hose inserted correctly.

- The picture below left shows the fill tube inserted properly in the fitting. Only a short length of the tube is visible inside the opening. A shorter amount of visible tubing is also correct.
- The picture on the right shows the black mark on the fill tube. This mark can be used as a guide, but always inspect the tube from the inside to verify correct positioning. The mark should be completely visible.

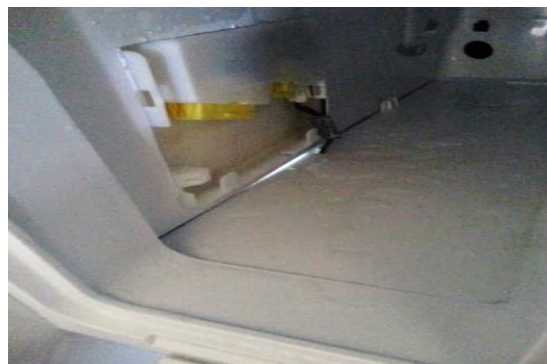
### **Abnormal Gap**

There is a gap between the liner and the floor of the ice room. The gap is due to variances in the surfaces. Warmer air from the FF section is drawn into the ice room, causing condensation and slushy ice.

- Remove the ice maker and the auger motor assembly following the correct procedures.
- Apply a bead of RTV Epoxy to the seam **from back to front** (see illustration below).
- Best results are achieved when the ice room is dry and warm, but do not use a heat gun or hair dryer to assist.

**Part number: DA81-05595A A/S Epoxy**

**Note:** Shine a light from the bottom of the ice room to see the gap. If all you see is a dim light, that is not a gap, it is light passing through the foam seal. This is normal and no epoxy is needed. Check for other causes.

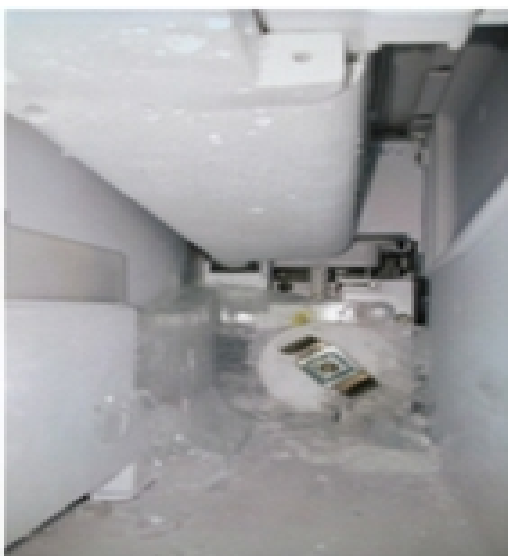
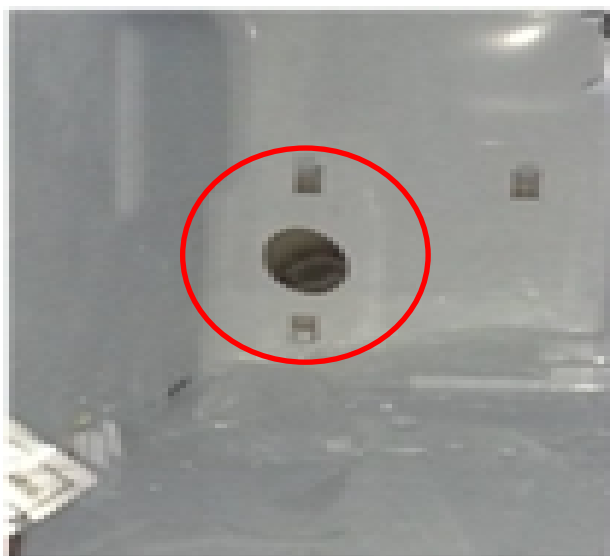
The drain tube that runs from the ice room to the drain pan is frozen or clogged. Water backs up into the ice room and freezes. The ice bucket becomes stuck or the system will not dispense properly.

- Use a steamer to defrost the ice buildup. This may take some time depending on the amount of ice.
- Remove the ice maker and auger motor, and then use a steamer to defrost the frozen drain.
