| SERVICE BULLETIN | |
| Product: | Bottom Mount and French Door Refrigerators |
| Bulletin Number | ASC20140703001 |

**Subject:** Water leaking under crispers and/or fan noise that stops when the doors are opened. This bulletin replaces any previous bulletin.

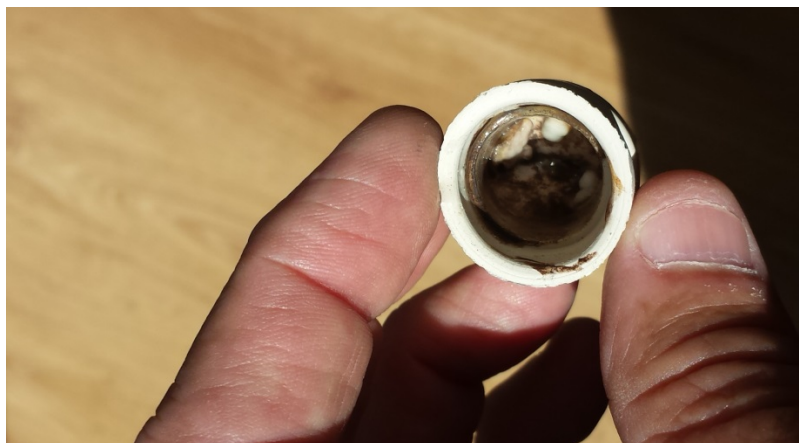
**Symptom 1:** FF section drain tube becomes clogged due to debris in the “duck bill”. The defrost water then backs up into the drain pan under the evaporator, where it will freeze. Every time the evaporator defrosts, water will then run over the drain pan, collecting under or in the vegetable drawers.

**Note:** The most important component of this repair is the installation of the new drain tubes after you have cleared the drain. Once these tubes are installed, if the new duck bill becomes clogged, the drain water cannot travel back up the drain pipe and freeze again. This will also prevent freezing in the freezer section drain.

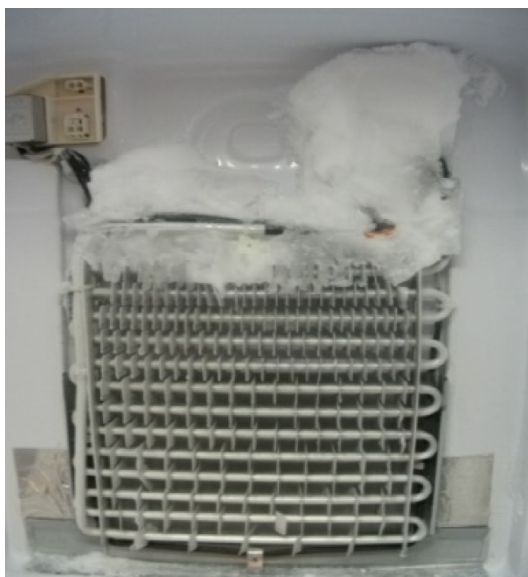
**Symptom 2:** Ice forms at the top of the Fresh Food evaporator due to air infiltration or incomplete defrost. The ice interferes with the fan, creating a noise that stops when the door is opened.

1. Unplug the refrigerator, and then remove the compressor compartment cover.
2. Remove the two external drain tubes with the duck bills.
3. Remove the evaporator cover.
4. Inspect the evaporator for ice build-up at the top. Melt any ice completely using a steamer.
5. Verify that the resistance of the defrost heater is correct. Also verify that the resistance of the defrost sensor is correct. If either reading is incorrect, replace the defective part(s). If the defrost sensor was imbedded in ice, replace it. When attaching the defrost sensor, make sure the sensor faces LEFT.

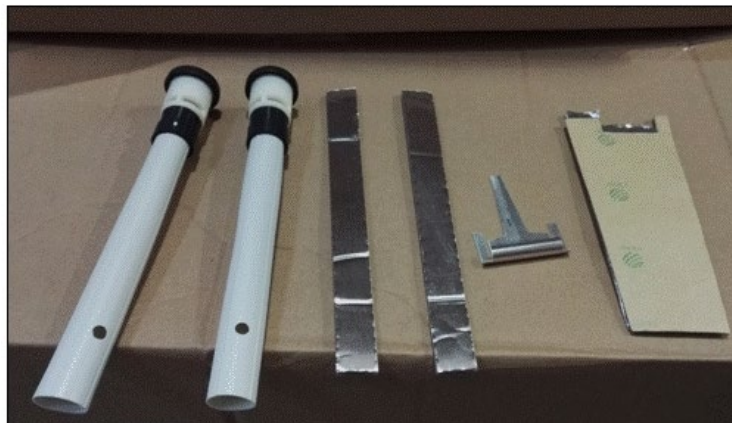
**Service Kit:**    Part Code DA82-01415A Leakage Kit

- 2 new drain tubes with caps
- 1 foam seal for the bottom of the evaporator drain plate
- 2 foam strips for the back of the evaporator drain plate
- 1 defrost heater drain clip.

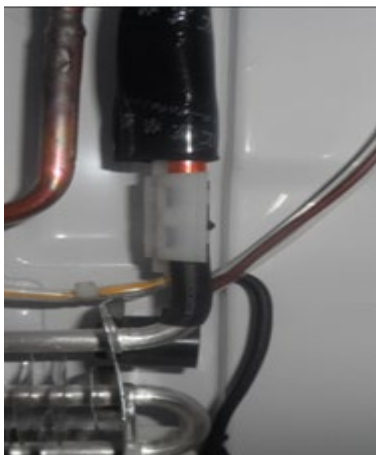
**Sensor facing rear (incorrect)**

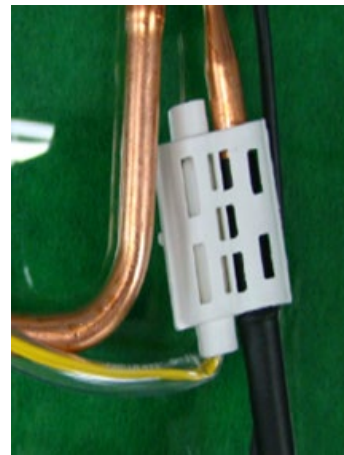
**Sensor facing left (correct)**

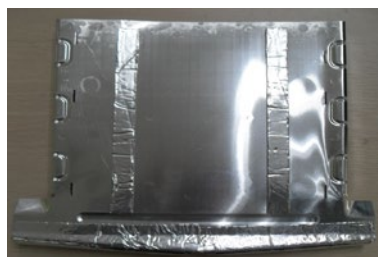
Foam strips installed (back and bottom)

6. Defrost the drain pan, if it is frozen, using a steamer. Be sure to defrost the drain pan and internal tube completely. Pour hot water down the drain to ensure the internal tube is clear and that water comes out at the bottom.
7. Lift the evaporator and drain plate out of position, and then carefully bend them up.
8. Add the two foam strips to the back of the plate, and then add the seal to the bottom of the drain plate.

**Note:** If foam seals are already installed on the drain plate, you do not need to add the new ones.

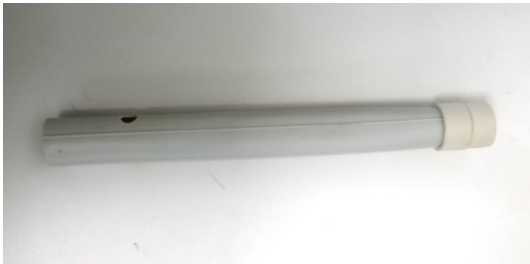
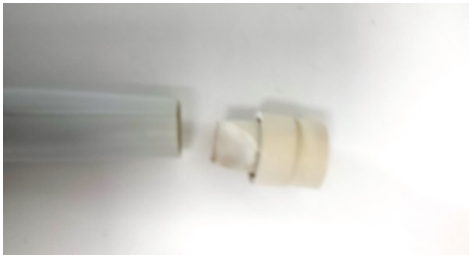
Original Style Drain Tube and Duck Bill

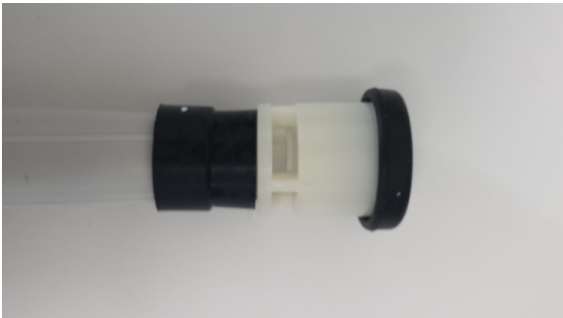
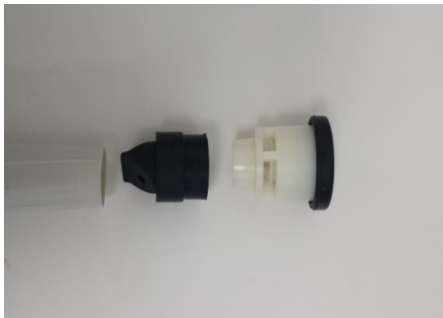
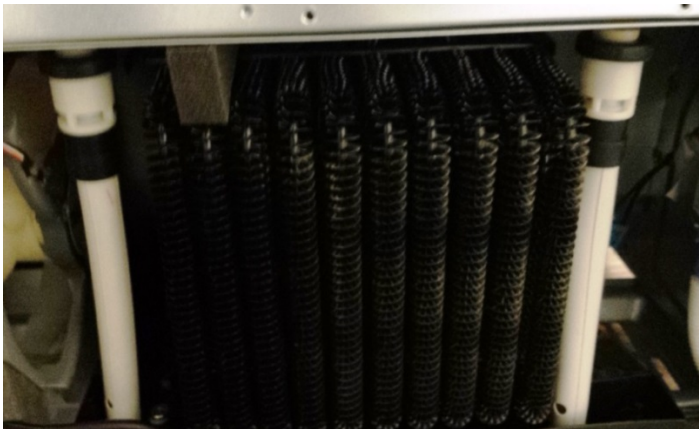
New Style Drain Tube with Duck Bill and Cap

12.Install the two new drain tubes with caps.
