| Title | <b>Unit Does Not Spin / Cycle Stops</b> | | |
| Create Date | October 30, 2017 | Service Bulletin Number | <b>ASC20171030001</b> |
| Revision Date | 3/27/2018 | Models | WA40J3000AW/AA<br>WA40J3000AW/A2 |

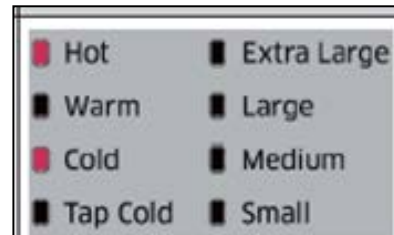
Wire harness tie can become disconnected from the motor die causing the red or blue wire to disconnect from the motor capacitor connector.

- Hot and Cold LEDs flash
- Unit does not spin
- Unit stops during the beginning cycle
- Cycle does not complete

- Determine if the red or blue wire from the main wire harness is disconnected from the motor capacitor connector.
- **IMPORTANT: If the red or blue wire is disconnected, the WIRE HARNESS (DC93-00702A) MUST BE REPLACED.**
- **✖ Reconnecting the wire harness only may cause the same problem later.**
